Exhibit H

EXHIBIT H - PHOTOGRAPHS

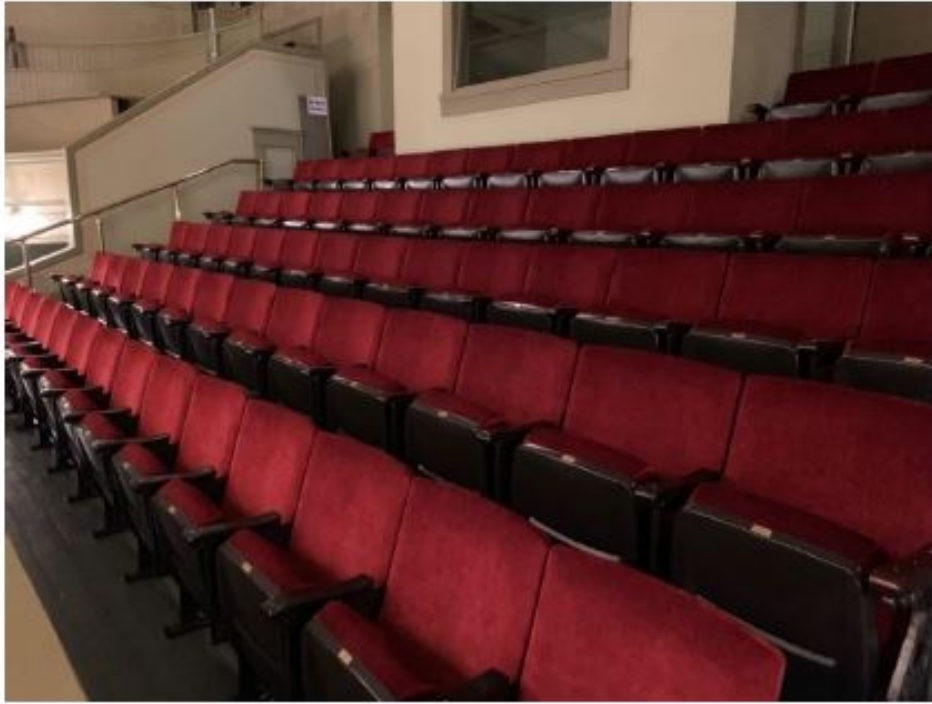
PHOTO #3: Seating in the 2nd floor balcony has very tight leg room, limiting ticket sales in these seats due to audience members being uncomfortable.

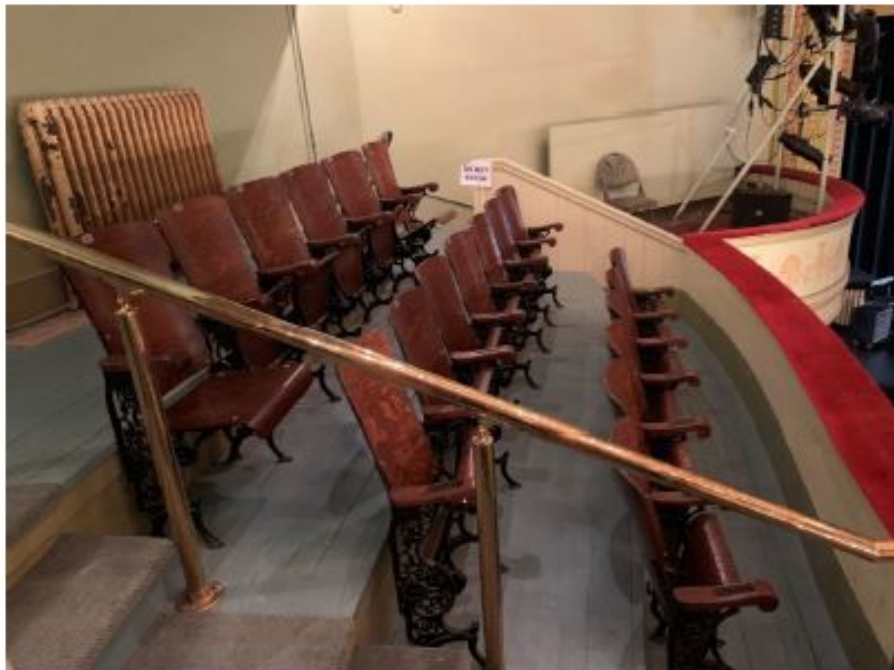
PHOTO #4: The side of the 2nd floor balcony contains the original seating. This was completed to honor the history of the facility. At the time, it was thought that the seating capacity of the theatre was sufficient, so a section could be dedicated to historic seating. However, with the success of new programming, seating capacity is a growing issue.

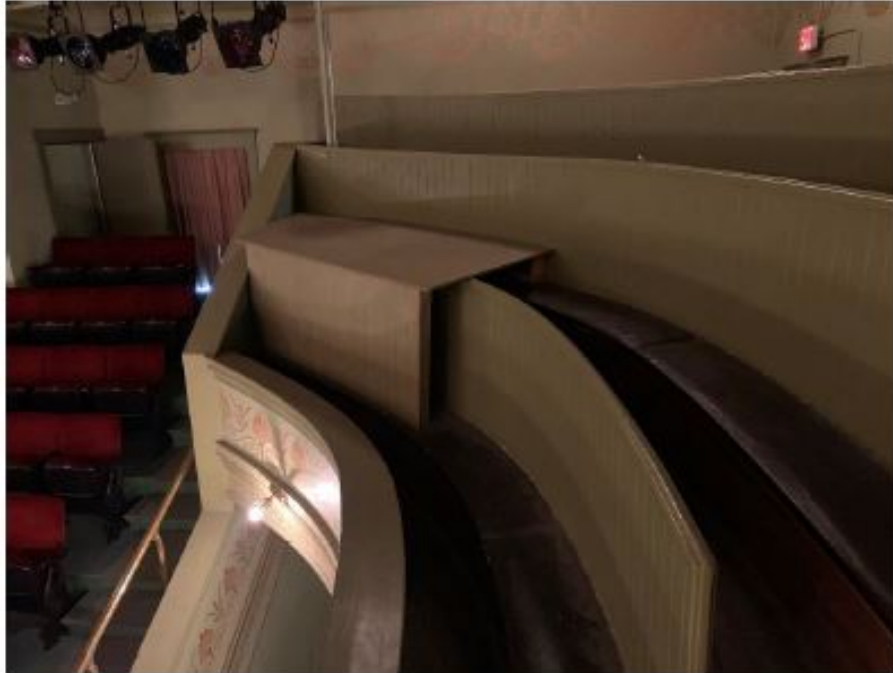
PHOTO #5: In the upper balcony, the original benches remain. The RRCA is interested in exploring what types of seating options could be installed in these spaces to increase seating capacity and create better audience experiences.

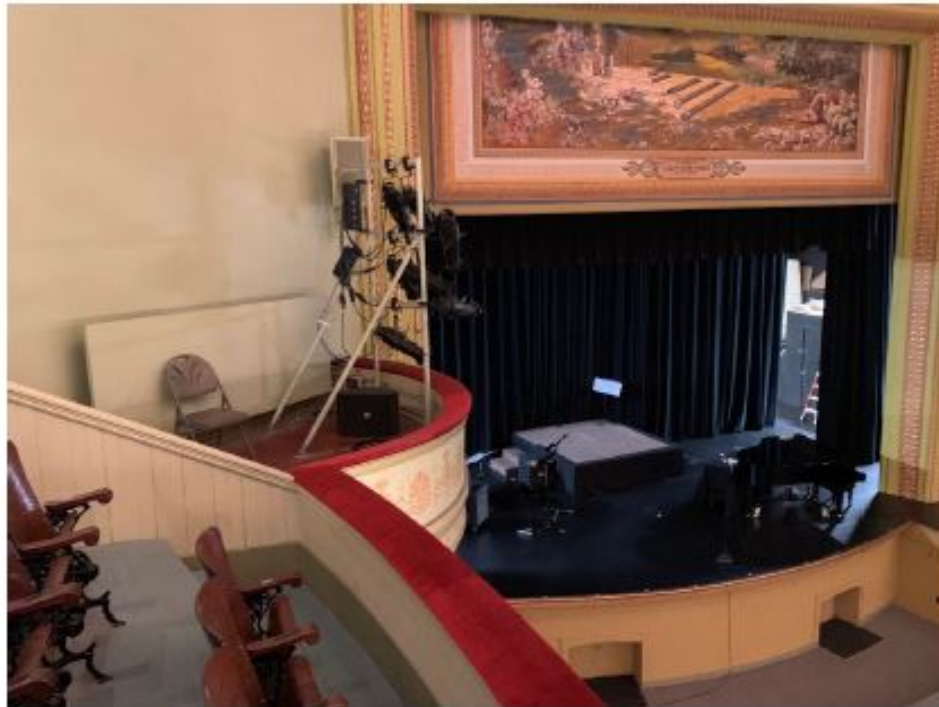
PHOTO #6: Light mounting is unsightly and is occupying space that could contain high-demand seating. Also, side lighting creates design challenges for theatrical productions.

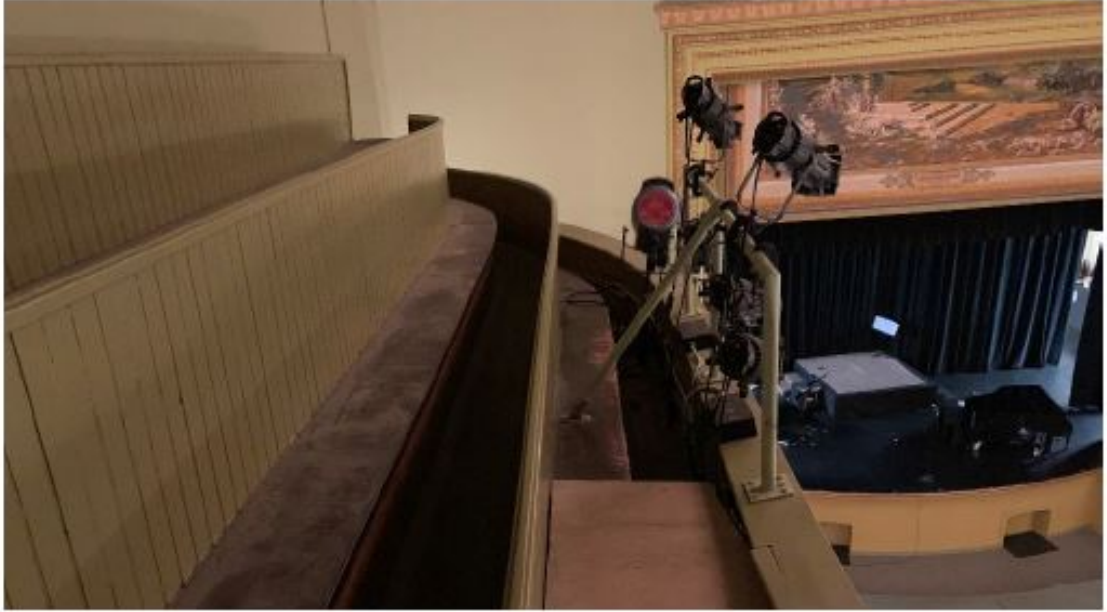
PHOTO #7: Another example of side lighting.

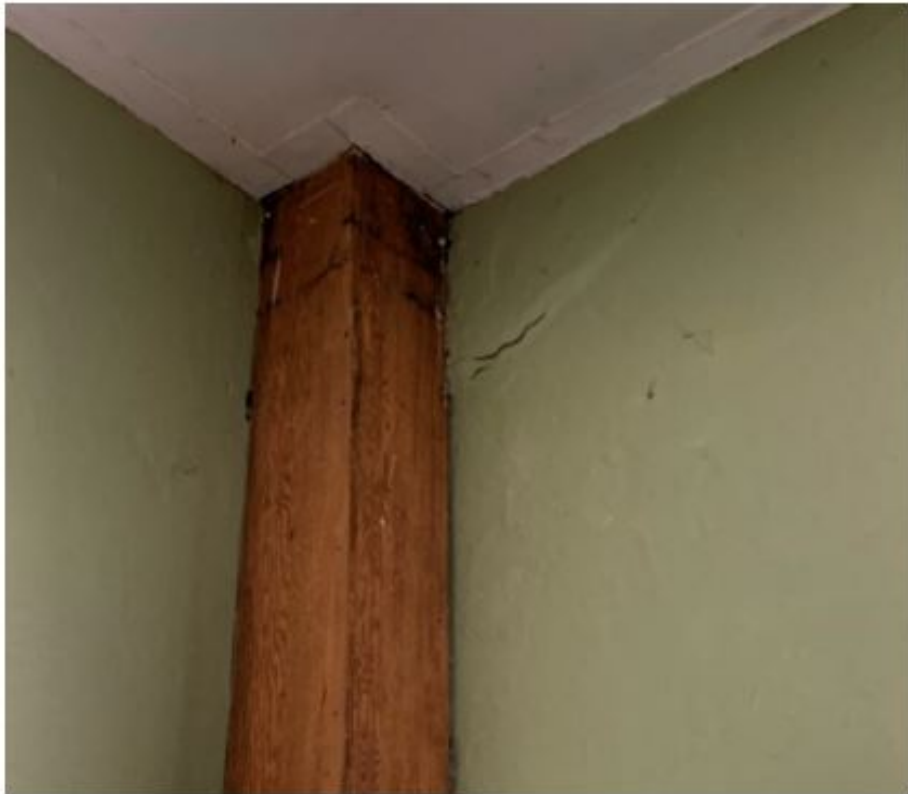
PHOTO #8: At various points in the facility, there is water/moisture damage leading to cracking in the plaster walls.

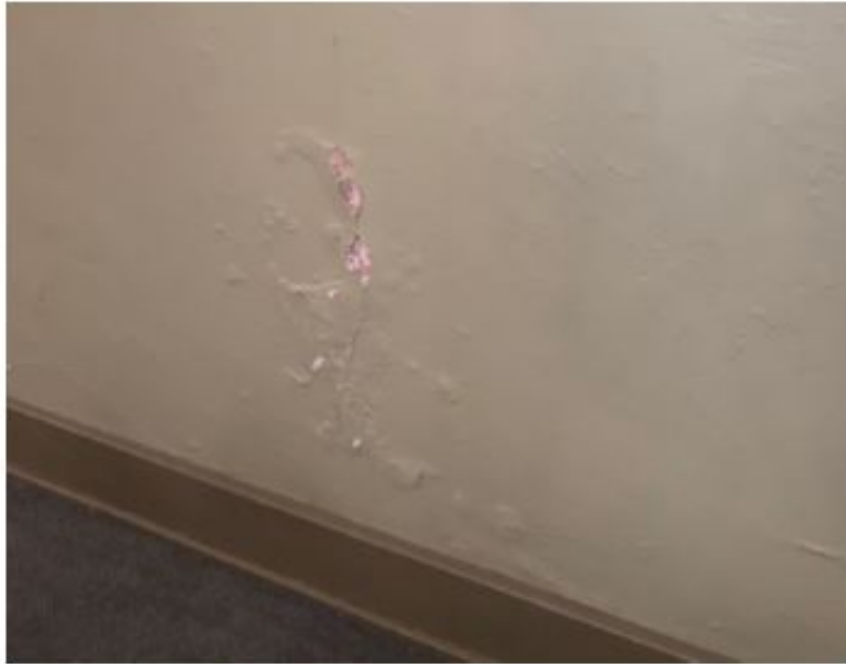
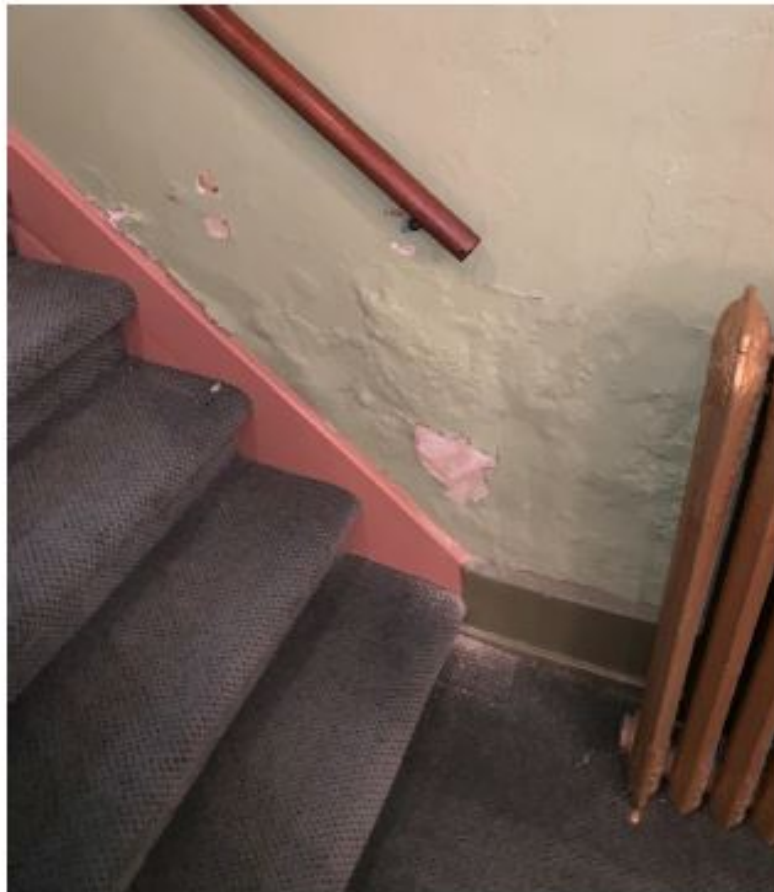
PHOTO #9 & #10: At various points in the facility, there appears to be water damage creating cracking in the plaster walls.

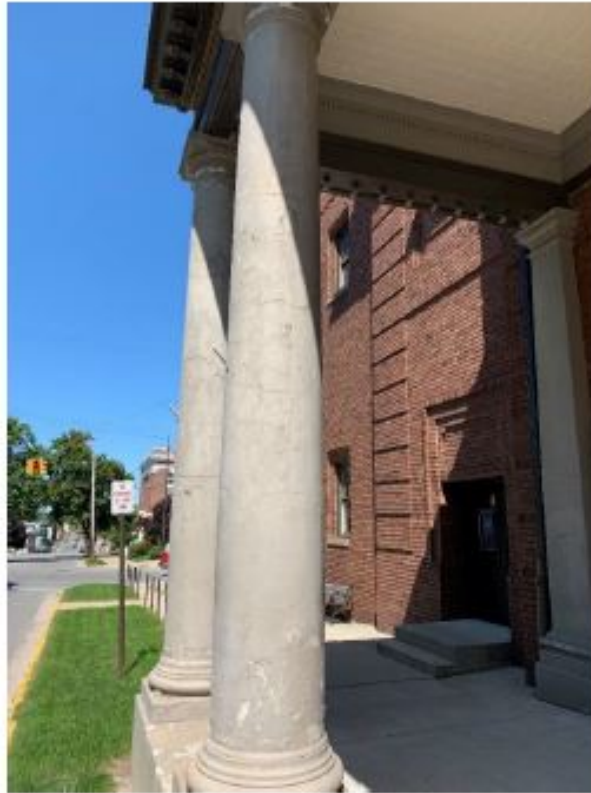
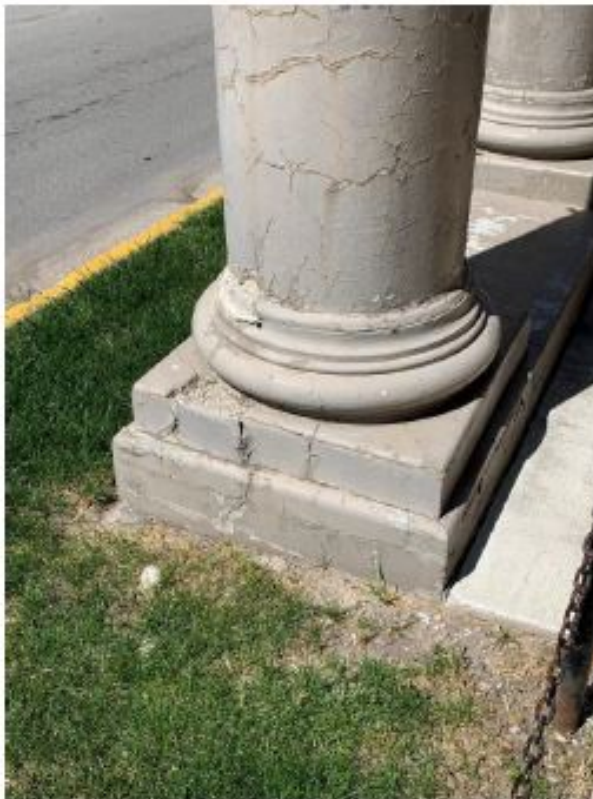
PHOTO #11 & #12: Concrete deteriorating on the columns at the entrance of the Ramsdell

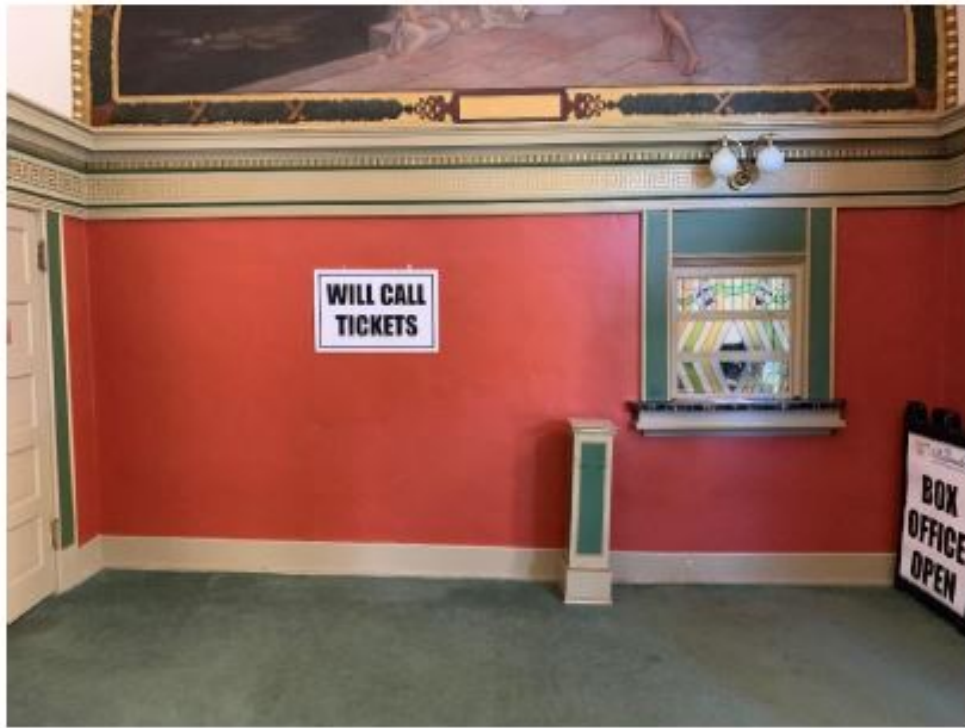
PHOTO #13: Exterior of ticket window. There is space to add at least one additional ticket window.

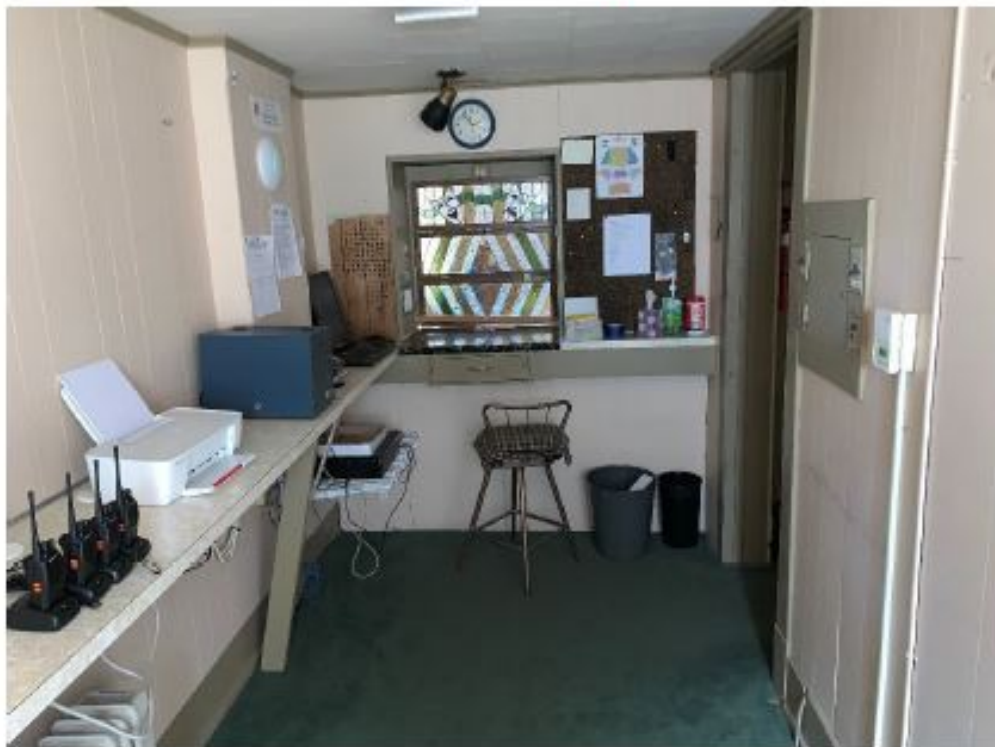
PHOTO #14: Interior of ticket booth. There is limited space for ticket booth workers.

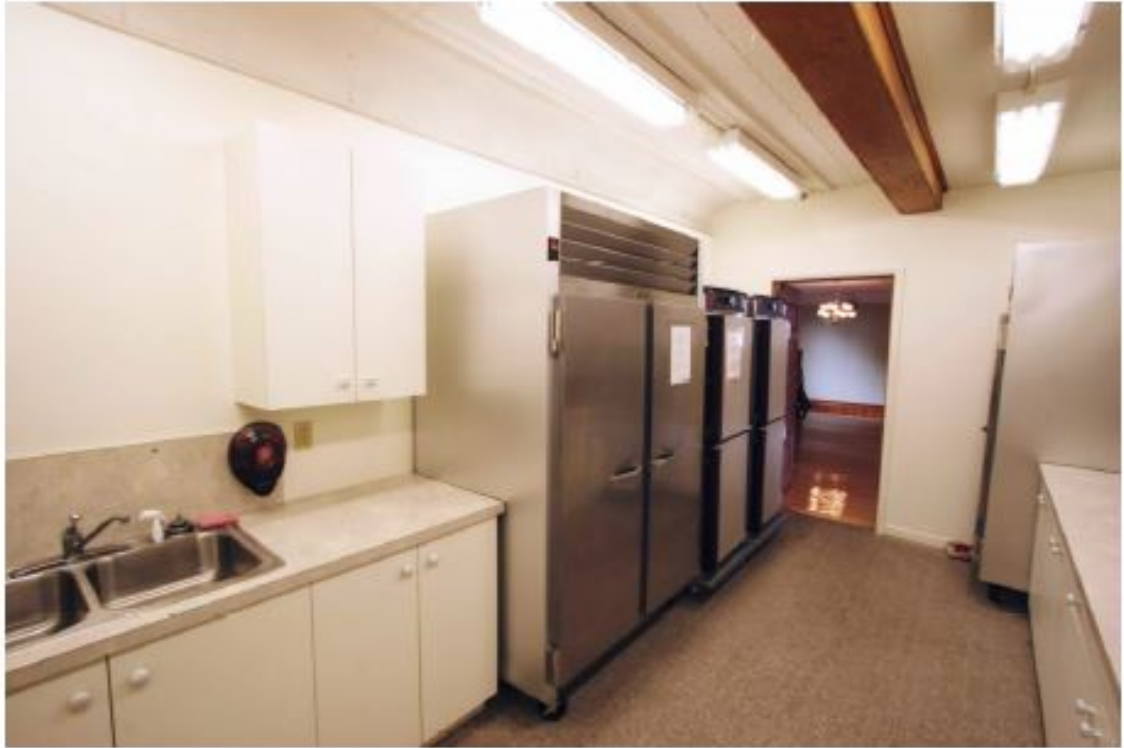
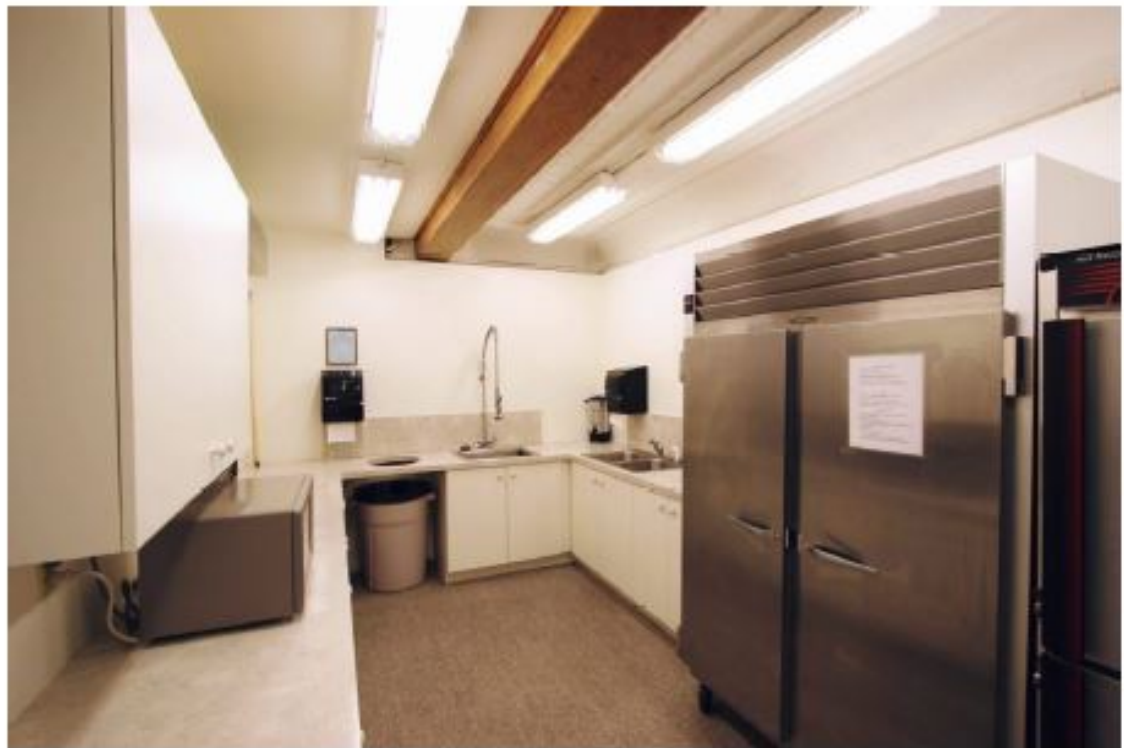
PHOTO #15 & #16: Food preparation space & appliances are limited.

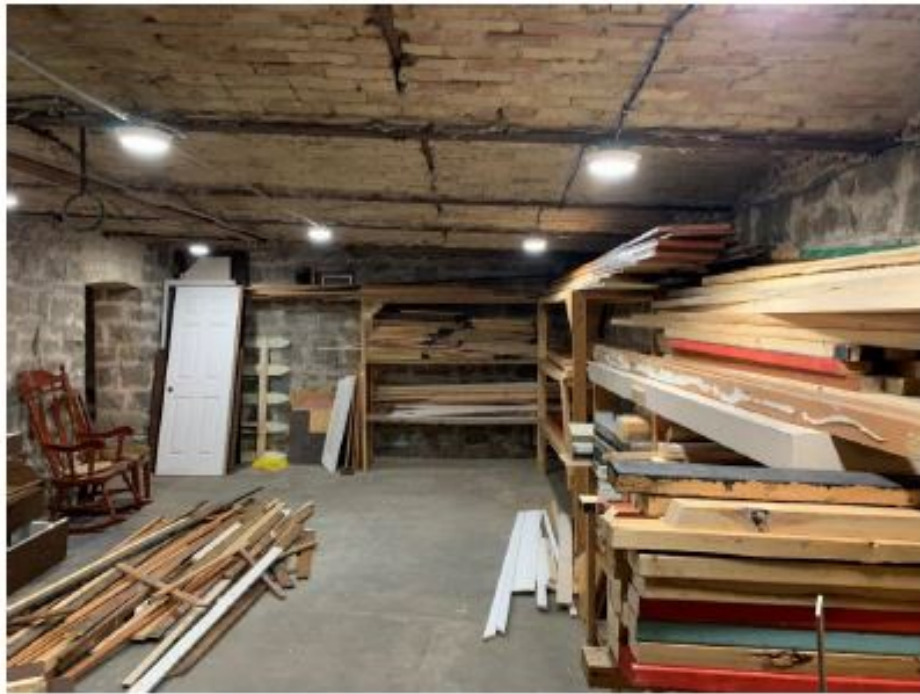
PHOTO #17: The area below the lobby has a distinct barrel-vaulted brick ceiling and brick walls, creating an appealing environment for a food and/or drink establishment.

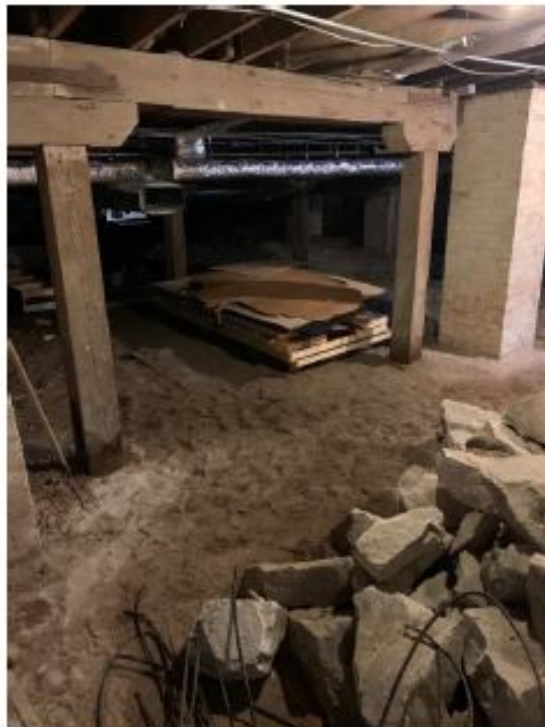
PHOTO #18: The area below the theatre, and adjacent to the barrel-vaulted room, mostly has a dirt floor which could be poured to create additional space for a food and/or drink establishment.
